**FOCUSED SITE INSPECTION PRIORITIZATION
SITE EVALUATION REPORT**

**SWIFT AG CHEMICAL FAIRMONT CITY PLANT
2501 NORTH KINGS HIGHWAY
EAST ST. LOUIS, ILLINOIS**

CERCLIS ID NO.: ILD059995423

Date Prepared: September 28, 1995
U.S. EPA Region: 5
Contract No.: 68-W0-0037
Technical Direction Document: T05-9503-237
Prepared by: Alix Rauschman
E & E Program Leader: Steven Skare
Telephone No.: (312) 663-9415

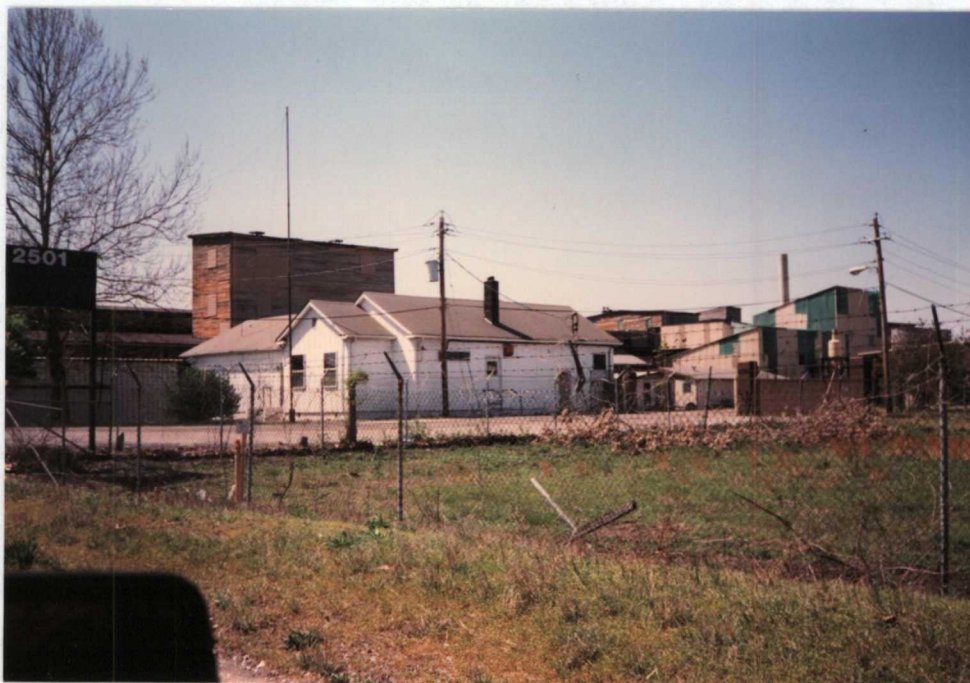
Photo: 2

Showing main entrance
with main building in
background.

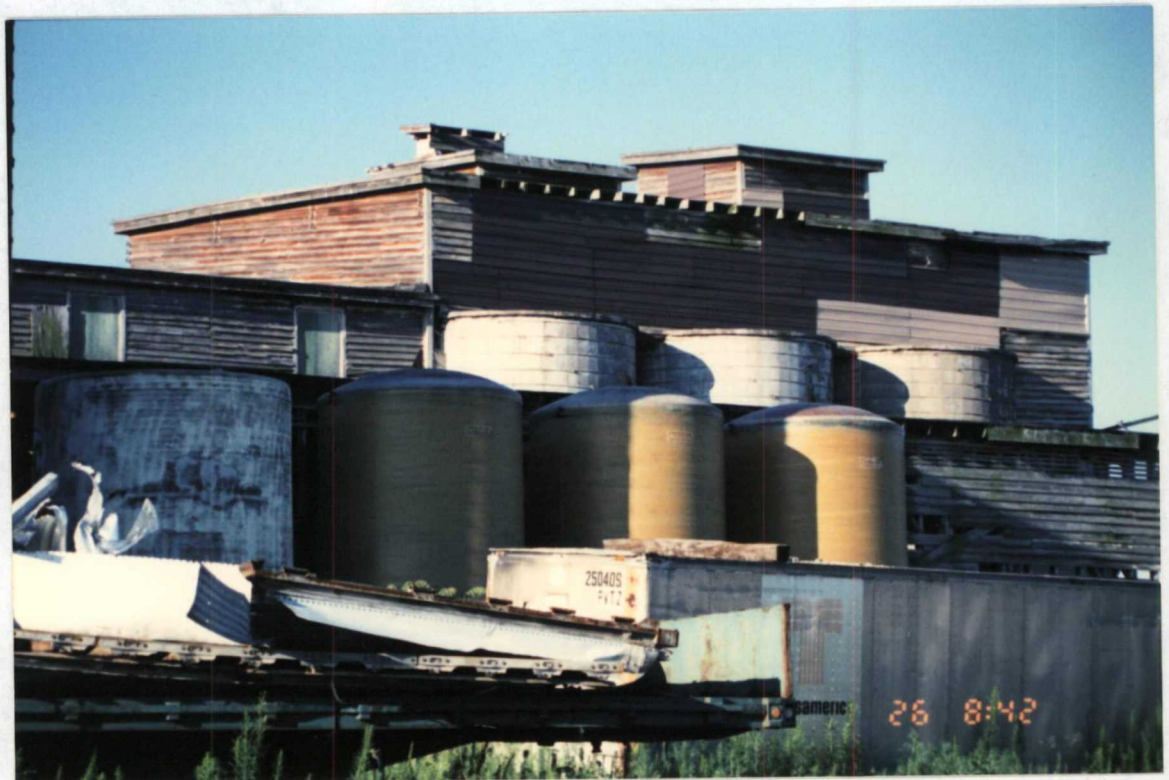
Photo: 4

Seven tanks are located at the northwest corner of Building #1 (see Appendix A, photograph 4). Three of the tanks, Nos. 9, 10, and 11, are empty silos which contained unknown prior contents. The other four tanks, Nos. 12, 13, 14, and 15, are surrounded by an earthen berm approximately three feet high. Tank #12 was empty at the time of the SSI and its prior use was unknown. Tanks #13 and #14 were once used to hold phosphoric acid, but were also empty at the time of the SSI. Tank #15, a 12,000-gallon tank, is used for storage of dust-suppressant oil. A small maintenance shed is also located northwest of Building #1 (E & E 1990; E & E 1995a).

Northwest corner of
the main building.
Showing silos 9, 10,
and 11.

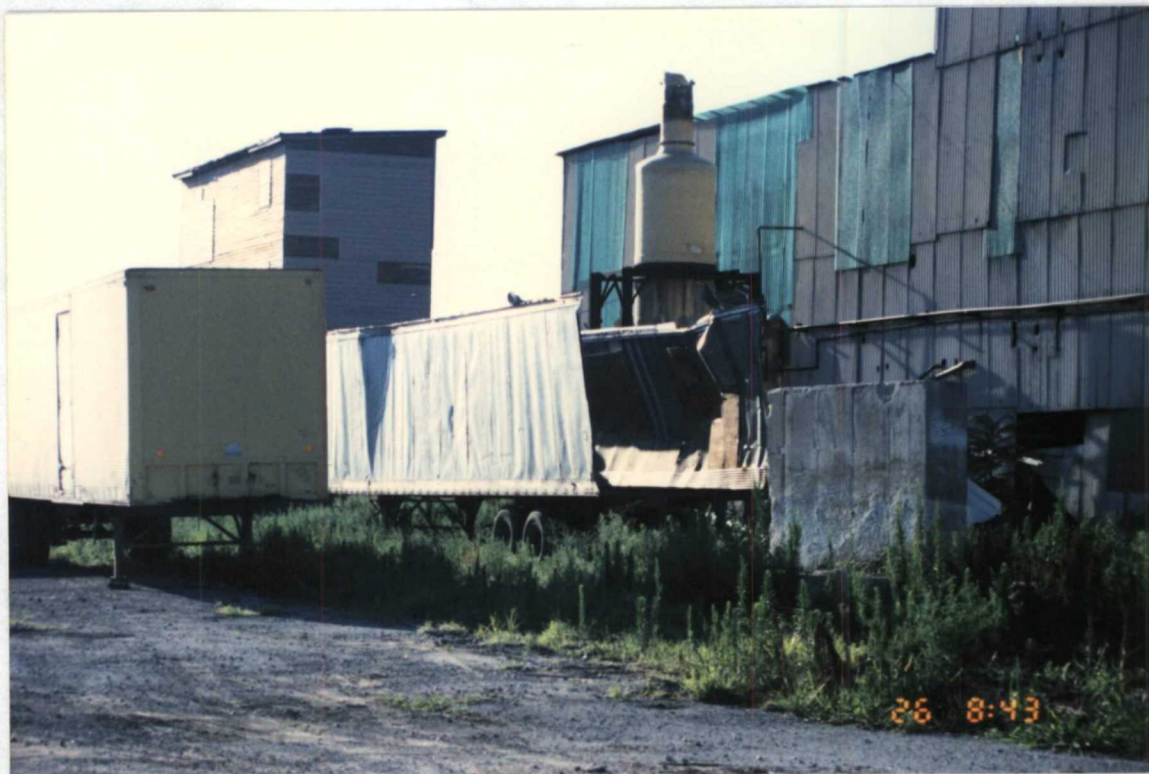
Photo: 7

East side of main
building.

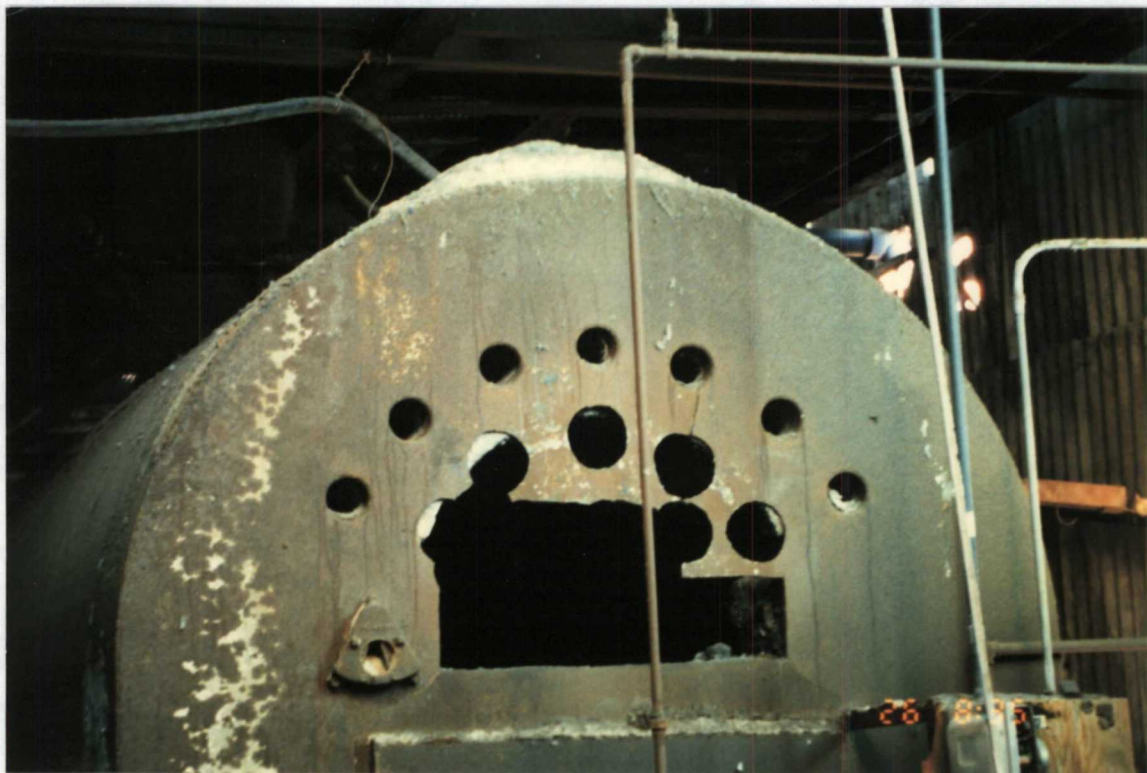
Photo: 8

Approximately 100 feet north of Building #1, there are six 100,000 gallon concrete tanks for solid fertilizers, and numerous liquid ammonia and fertilizer tanks (see Appendix A,

photographs 8 and 9). Mr. Kenna reported that all of the tanks were empty. This was confirmed during the 1995 site reconnaissance (E & E 1995a).

Empty concrete tank.

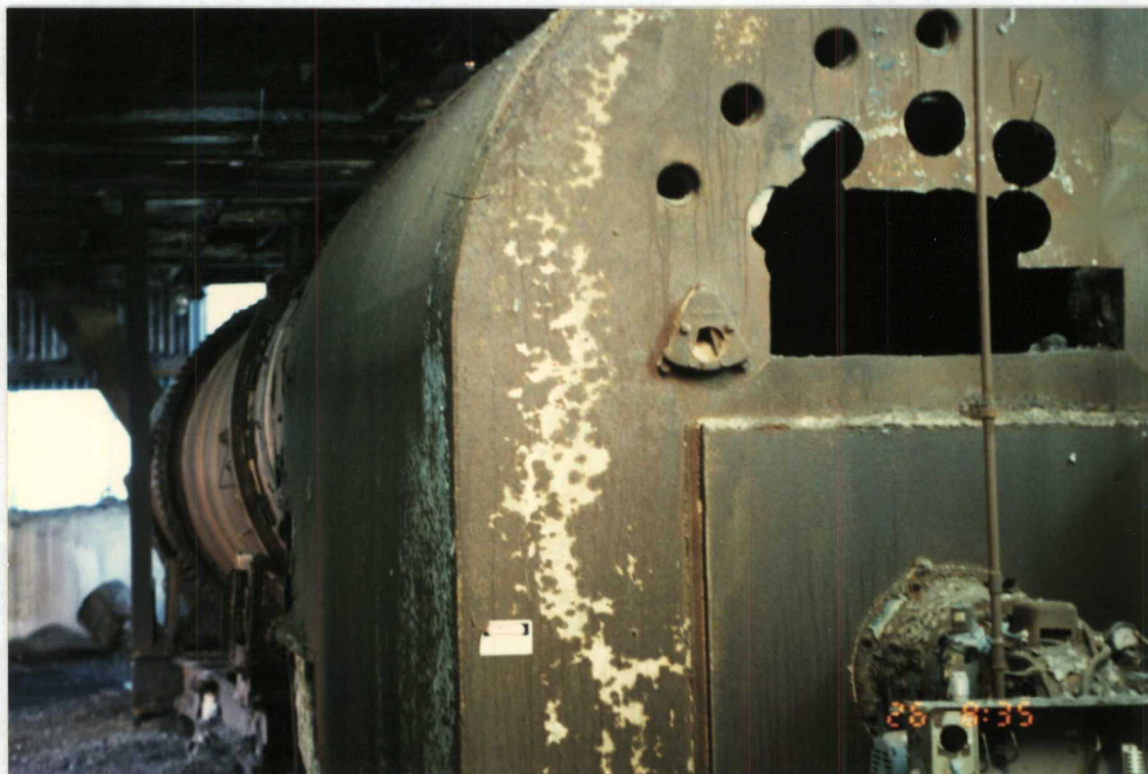
Photo: 9

Empty concrete tank.
